ENGINEERING DEVELOPMENT ESTABLISHMENT

EDE-PUBLICATION 4/87

GRID COMPASS COMPUTERS

ENGINEERING EVALUATION

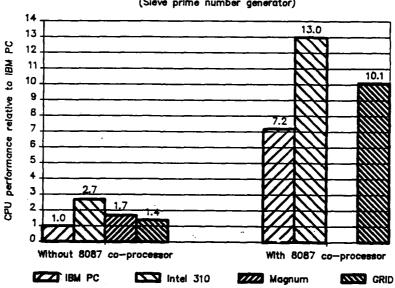
FIG 8 - CPU PERFORMANCE BENCHMARK RESULTS

- 49. Results and Discussion. The results relative to an IBM PC with no 8087 are presented in Table 2 and shown graphically in Fig 8. An IBM PC with no 8087 has a relative index of 1.0. Therefore a computer with twice the performance would have a relative index of 2.0. Without the 8087, the GRID computers exhibit approximately a 40% performance improvement over a standard IBM PC but have approximately half the performance of the Intel 310/286 machine. With the 8087 the GRID computers performance improves dramatically and is on a par with the Intel 310 when using its 80287 co-processor.

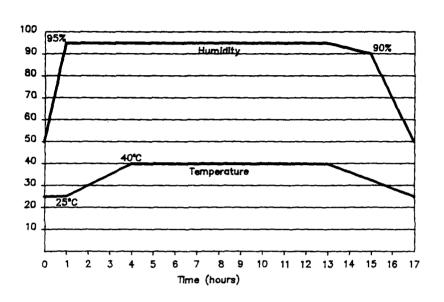
FIG 9 - HIGH TEMPERATURE, HIGH HUMIDITY CHARACTERISTICS DEF STAN 07-55 PART 2 SECTION 2/1 TEST B6 SEVERITY A

- 100. <u>Test Procedure</u>. Both GRID computers were subjected to a High Temperature, Diurnal Cycle High Humidity test as outlined in Ref E Test B6 Severity A Procedure A with a cyclic temperature of 40°C maximum for 16 hours. Both computers were placed in the test chamber and operated with the test program. The humidity and temperature test conditions are shown in Fig 9.
- 101. Results. Both GRID Compass computers operated correctly throughout the test cycle. The displays, keyboards and serial ports all operated correctly. The access times to the bubble memories were normal (see discussion for the High Temperature, Low Humidity test B2 in paragraph 83).

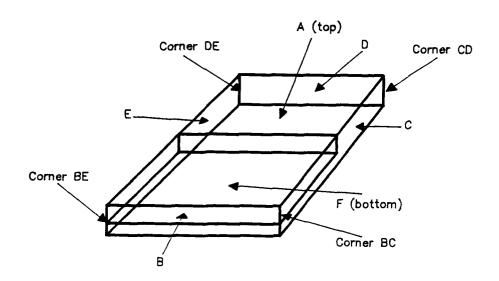
FIG 11 - FACE AND CORNER LABELLING FOR FREE FALL TEST
DEF STAN 07-55 PART 2 SECTION 1/1 TEST A9

on to 19 mm thick pineboard. Fig 11 shows the face and corner labelling. If the computer passed this test a drop test would then be conducted with the computer in its carry satchel from a height of 80 cm on to 19 mm thick pineboard. 80 cm is the average height from the ground of an item being carried like a brief case.

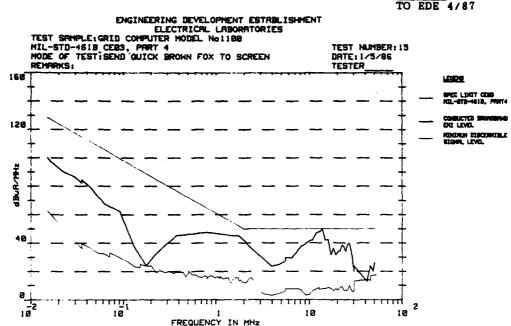
FIG 15 - STANDARD MODEL 1100 GRID COMPUTER CONDUCTED BROADBAND EMISSIONS (ACTIVE LINE)

- 62. Conducted Broadband Results. The Tempest GRID computer failed to meet the specification limit CE03 of Ref B for conducted broadband emissions over the frequency range 1.2 MHz to 2.5 MHz by up to 5 dB on both the active (Annex B Fig 16) and neutral (Annex B Fig 18) power supply lines. The Standard GRID computer met this specification limit on the active (Annex B Fig 15) and neutral lines (Annex B Fig 17).

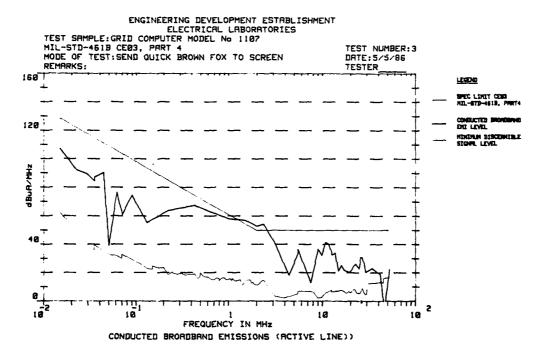
FIG 16 - TEMPEST MODEL 1107 GRID COMPUTER CONDUCTED BROADBAND EMISSIONS (ACTIVE LINE)

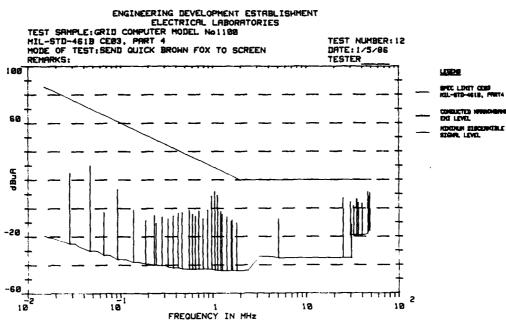
FIG 19 - STANDARD MODEL 1100 GRID COMPUTER CONDUCTED NARROWBAND EMISSIONS (ACTIVE LINE)

- 63. Conducted Narrowband Results. Both GRID computer models meet the specification limit CEO3 of Ref B for conducted narrowband emissions for both the active and neutral power supply lines. Fig 19 (Standard GRID) and Fig 20 (Tempest GRID) of Annex B show the results for the active line. Fig 21 (Standard GRID) and Fig 22 (Tempest GRID) of Annex B show the results for the neutral line.

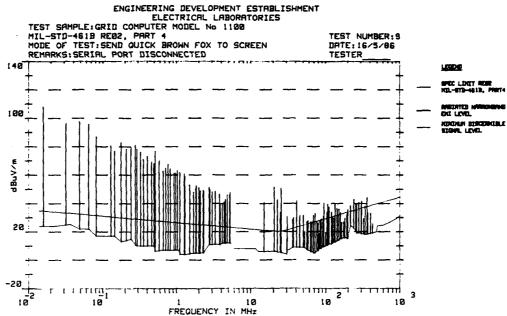
FIG 26 - TEMPEST MODEL 1107 GRID COMPUTER RADIATED NARROWBAND EMISSIONS (ELECTRIC) SERIAL CABLE DISCONNECTED

- 66. Radiated Narrowband Results (No serial cable). Disconnecting the RS232 serial cable produced a noticeable drop in high frequency emissions (Annex B Fig 26) for the Tempest GRID computer when compared to the results with the serial cable shown in Annex B Fig 24. The Standard GRID computer showed no drop in emissions level (Annex B Fig 25) when compared to the results with the serial cable shown in Annex B Fig 23.

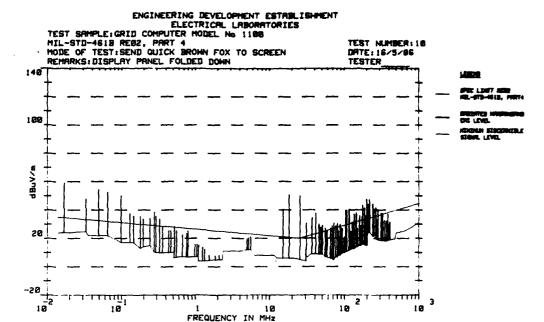
FIG 27 - STANDARD MODEL 1100 GRID COMPUTER RADIATED NARROWBAND EMISSIONS (ELECTRIC)

- 67. Radiated Narrowband Results (Panel down). Folding down the display panel produced a significant drop in radiated narrowband emission levels for both computers across the whole frequency range of 18 kHz to 420 MHz. The results are shown in Annex B Fig 27 for the Standard GRID computer and in Annex B Fig 28 for Tempest GRID computer. The Tempest GRID computer almost meets the specification limit RE02 of Ref B with the display panel folded down. The Standard GRID computer fails to meet the specification. Note that operation with the display panel down would not be the normal operating normal mode.

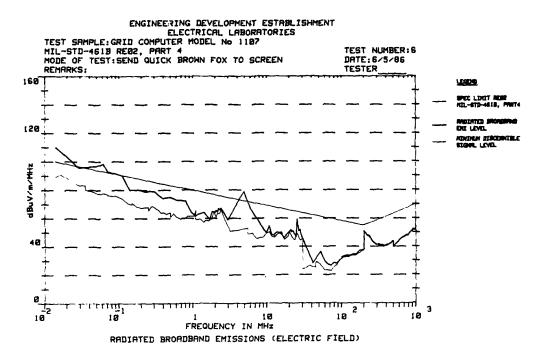
- Radiated Broadband Results. The Tempest GRID computer failed to meet the specification limit RE02 of Ref B for radiated broadband emissions over the frequency range 15 kHz to 120 kHz and 4 MHz to 6 MHz by up to 10 dBuV/m/MHz (Annex B Fig 29). The Standard GRID computer failed to meet the specification and exhibited numerous radiated broadband emissions. Accurate broadband emissions measurements were not taken for the Standard GRID computer as they serve no useful purpose in a unit which also exhibits a large amount of narrowband emissions; therefore no graph is provided.

FIG 29 - TEMPEST MODEL 1107 GRID COMPUTER RADIATED BROADBAND EMISSIONS (ELECTRIC)
